### 09-316 Senumstad bru Hovedinspeksjon 2015

27. mai 2015 H. Ludescher og A. Martin Galan Dr.techn.Olav Olsen & Fhecor Consulting Engineers

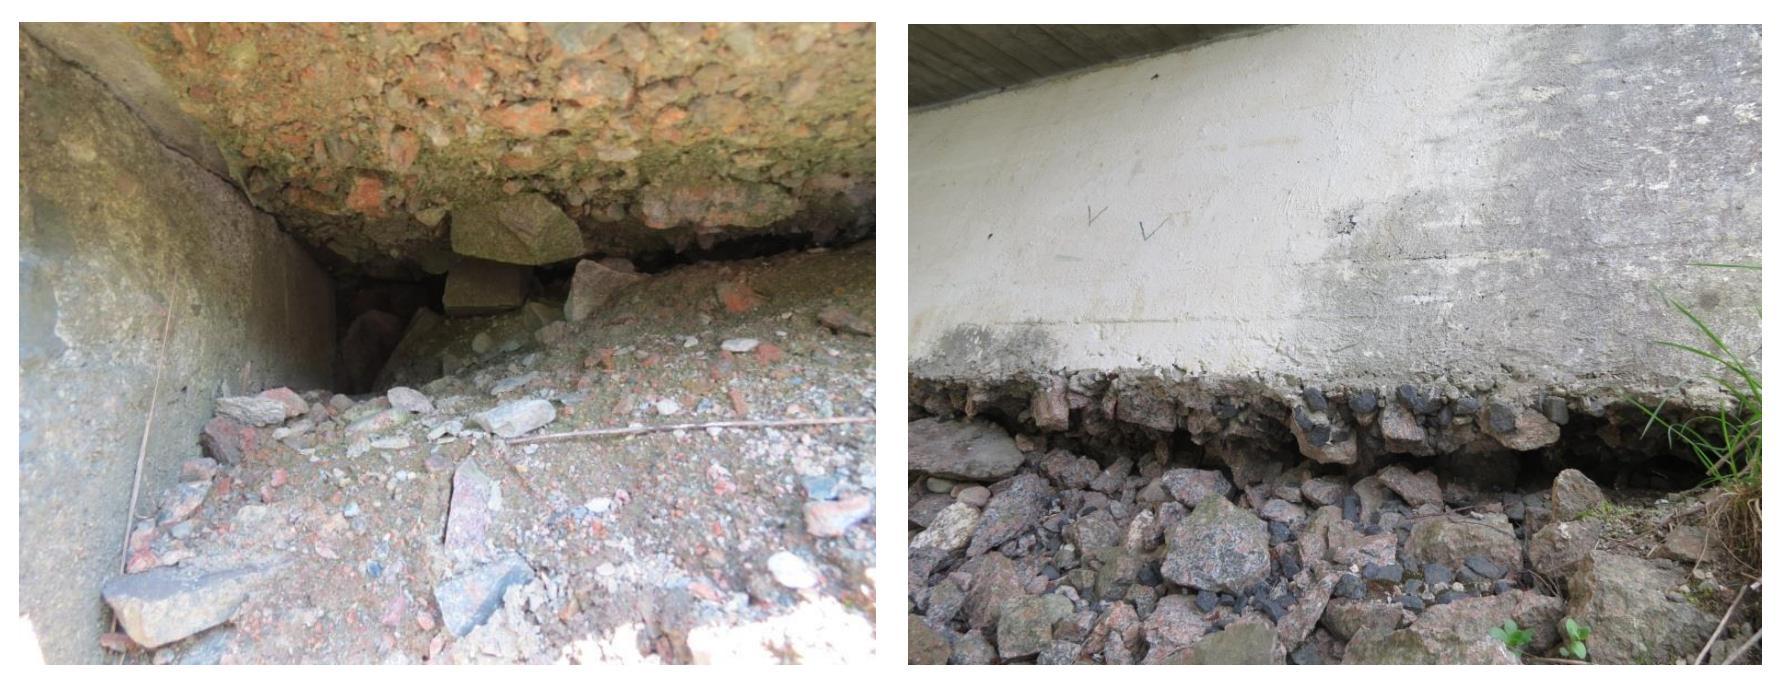
#### Abutments

- Good condition
- Previous leakage through joint caused minor erosion
- Stabilized settlement at abutment axis nº 1

Elements	Recommendation
Concrete elements (deck, abutments and concrete pylons)	Patch repair where spalling and corrosion is appeared within 3 years Improvinig erosion protection against erosion within 7 years
Steel elements (longitudinal and transverse girders and steel towers)	Re-painting within 7 years Remove debris from longitudinal beams
Cables, hangers and connections	Re-painting within 3 years
Railing	Re-painting within 3 years and replacing railing damaged by impacts
Drainage system	Enlarge drainage pipies in concrete pylons

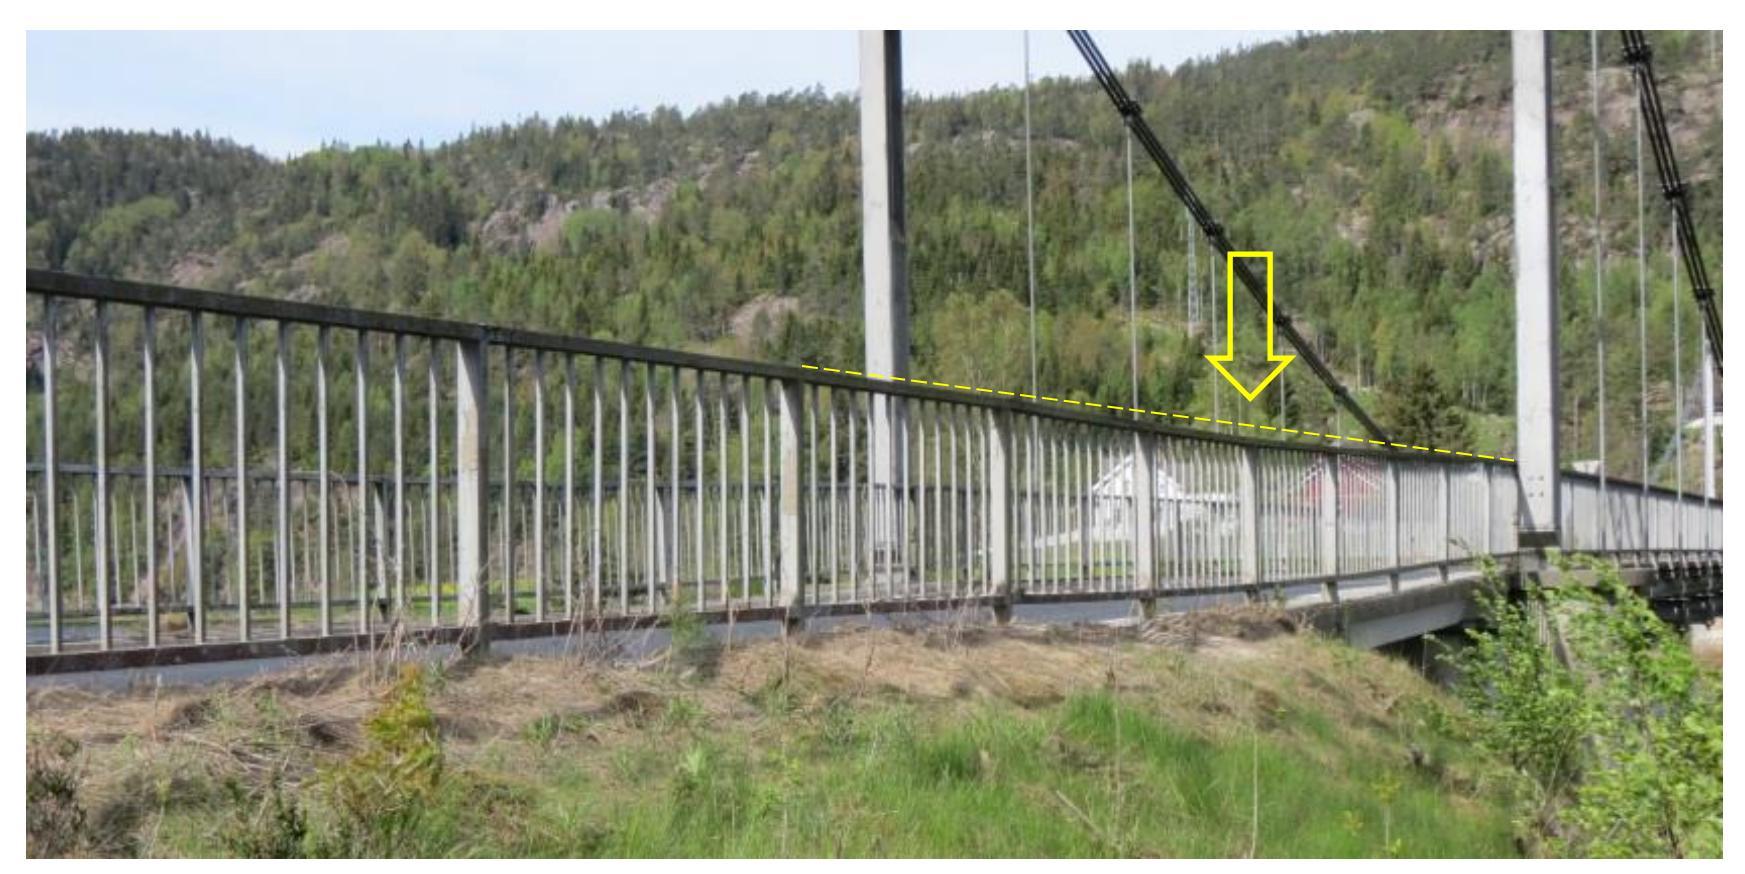
#### Abutments

• Settlement at abutment axis nº 1

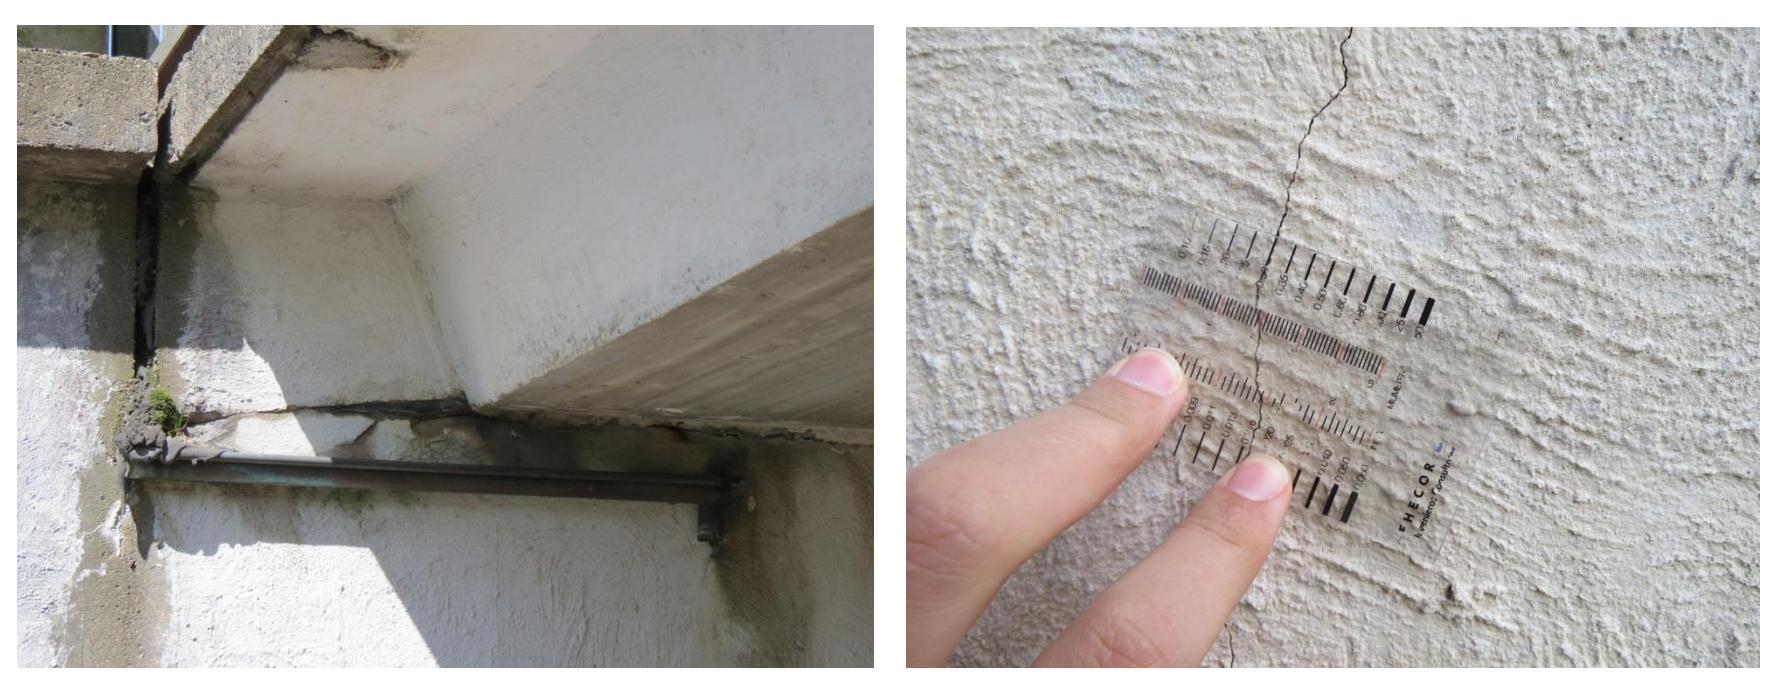
## Concrete pylons

- Good condition
- Leakage due to too short drainage pipes
- Insignificant cracks

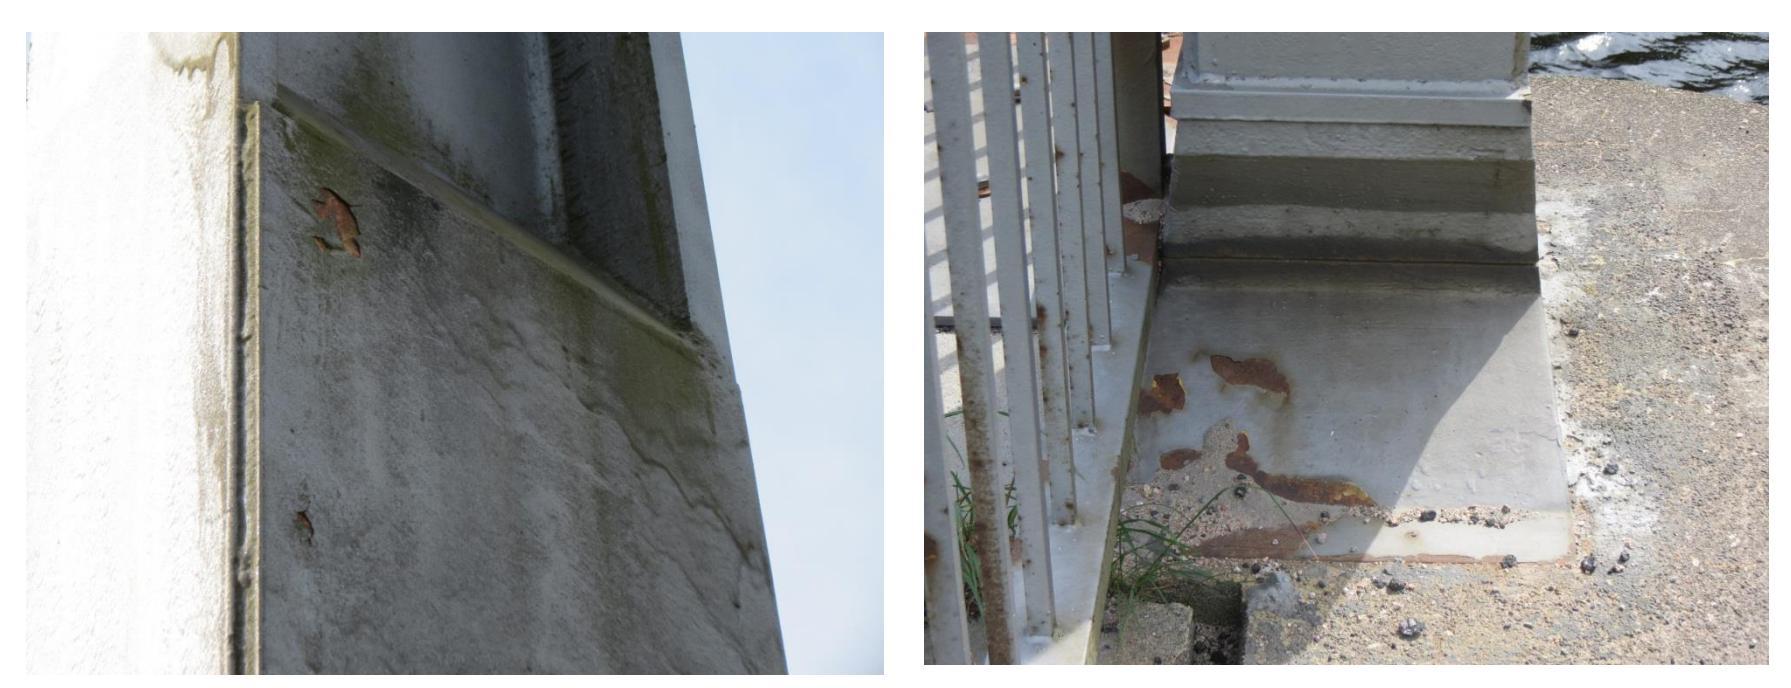
# Steel pylons

- Good condition
- Punctual corrosion due to a lack of maintenance
- Minor damages

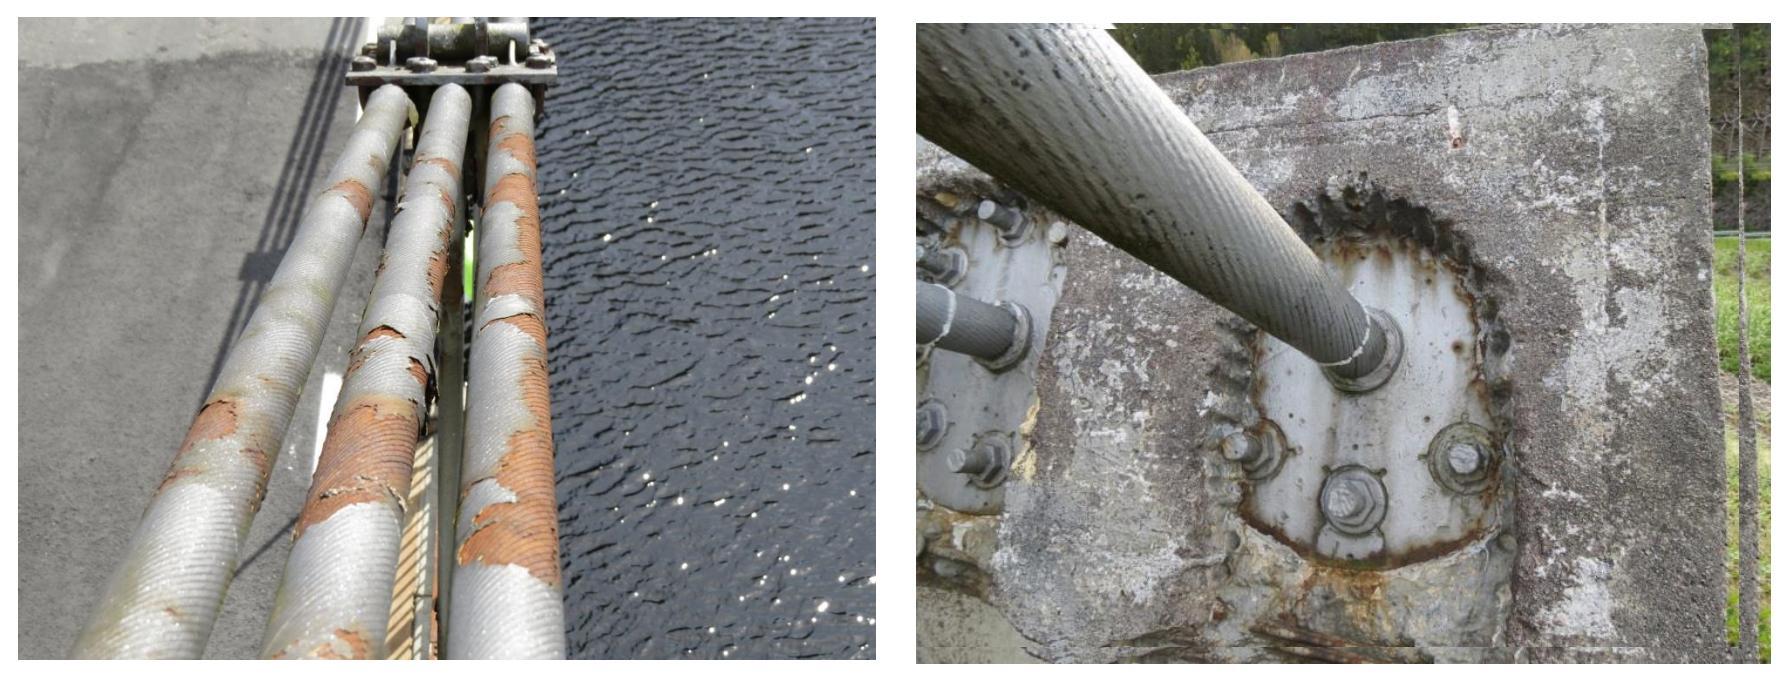
## Main cables

- Starting corrosion due to spalling of painting
- Steel plates anchorage in good conditions

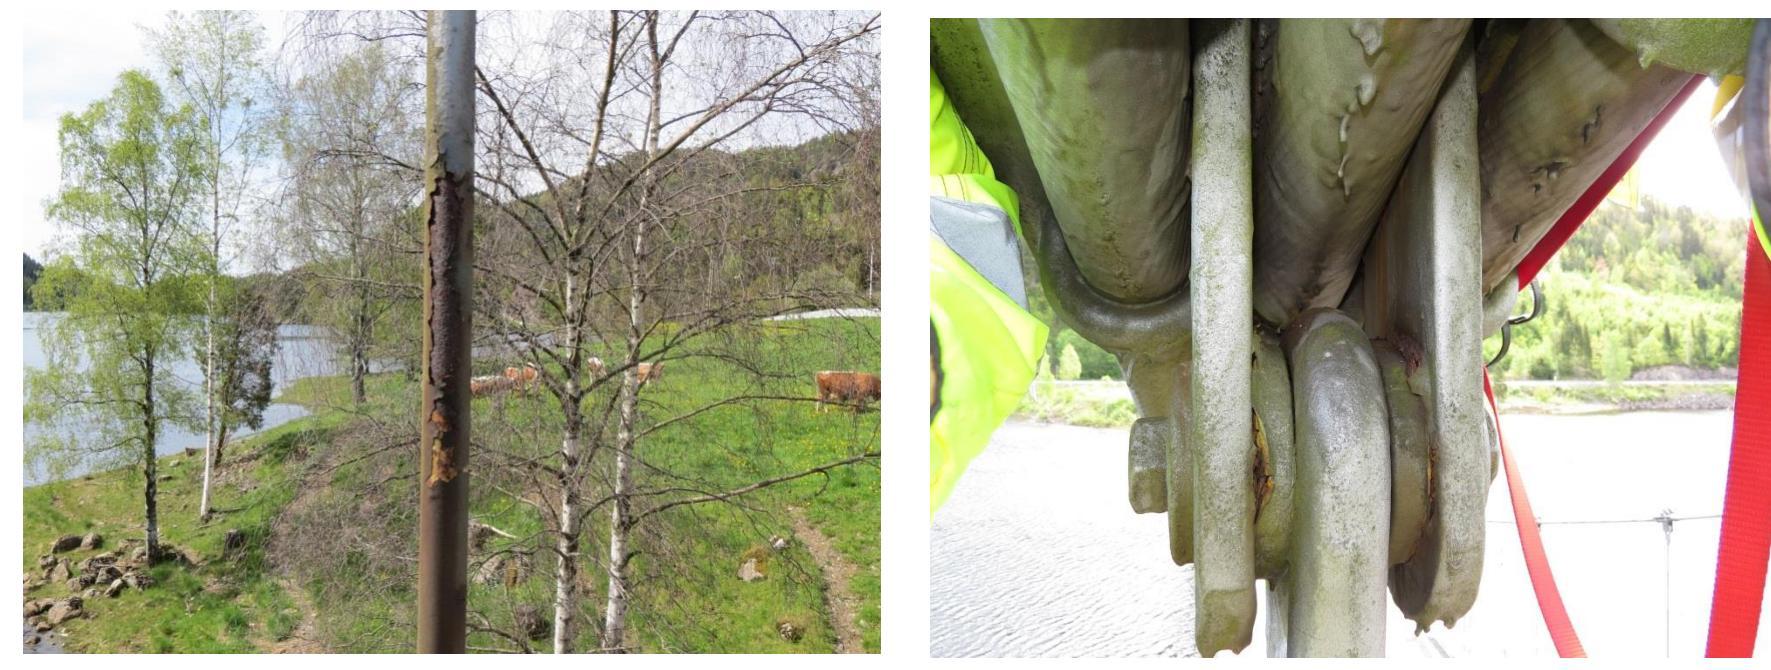
#### Hangers

- Punctual corrosion in hangers and conections with main cables.
- Losses of painting on some bolts

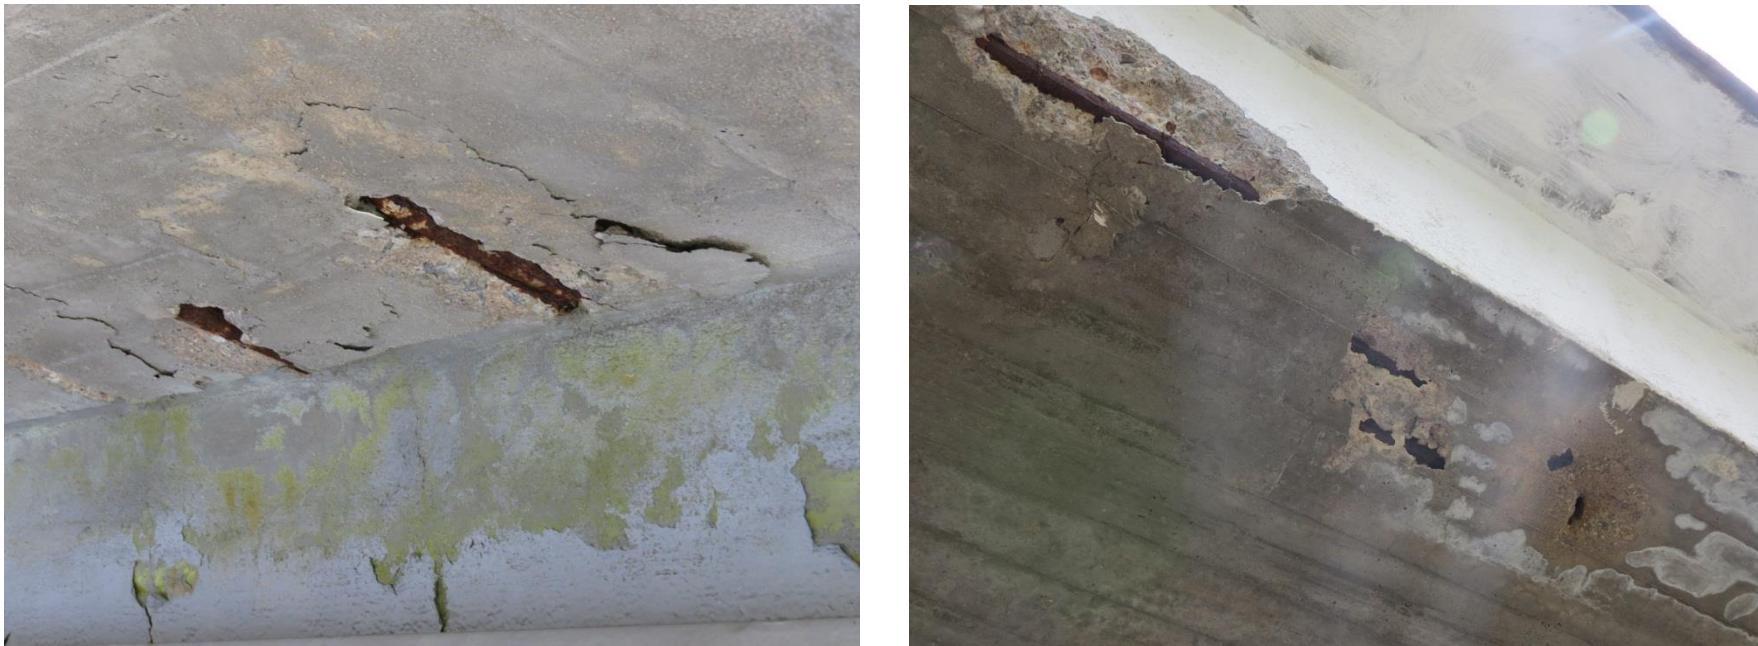
### Concrete deck

- Good condition in general terms
- Spalling and corroded rebars due to insufficient concrete cover, especially in access spans
- No significant cracks over abutments

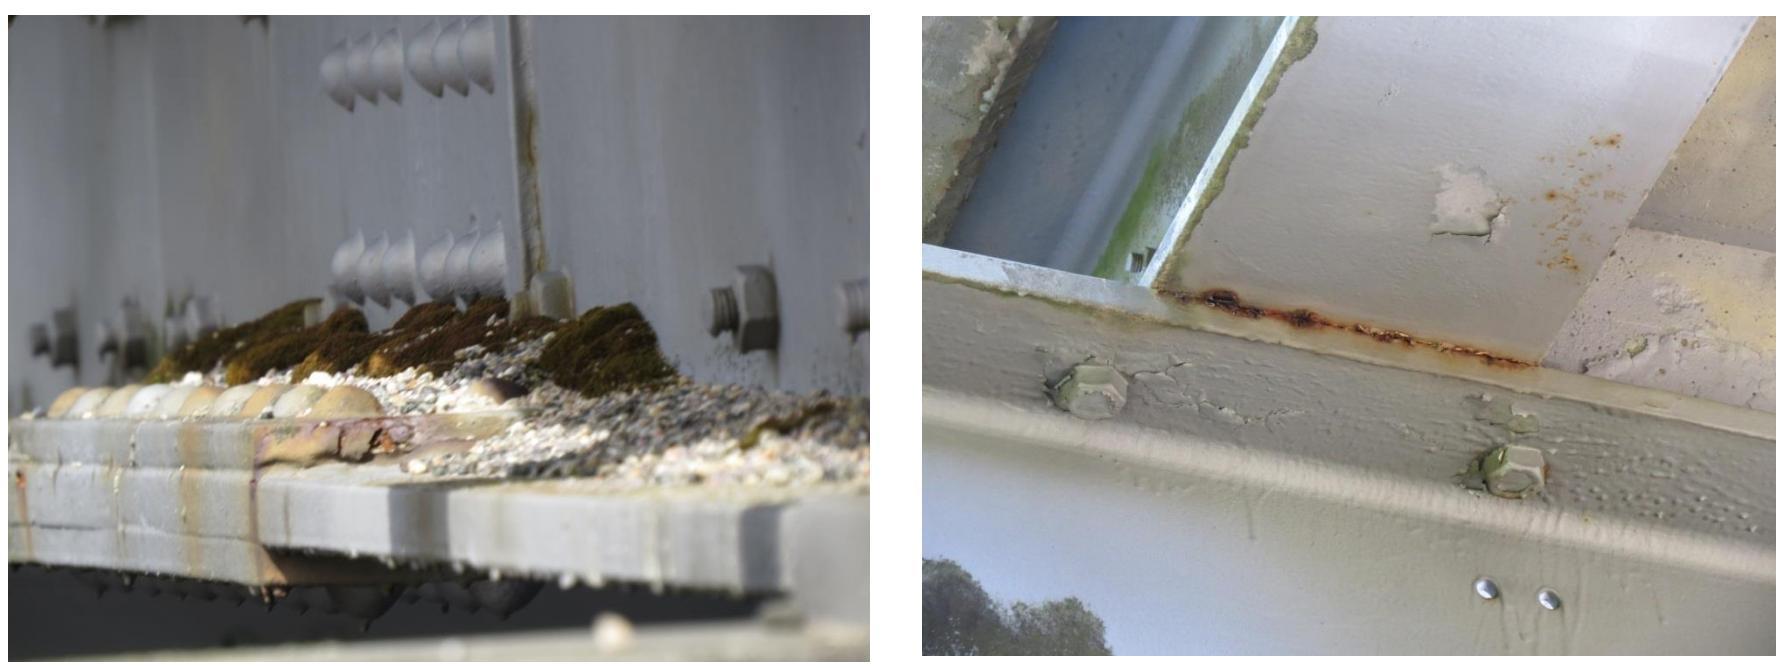
# Edge steel girders

- Generally good condition, some debris and vegetation
- Deterioratio of painting and starting corrosion
- Minor damages in contact with transverse girders

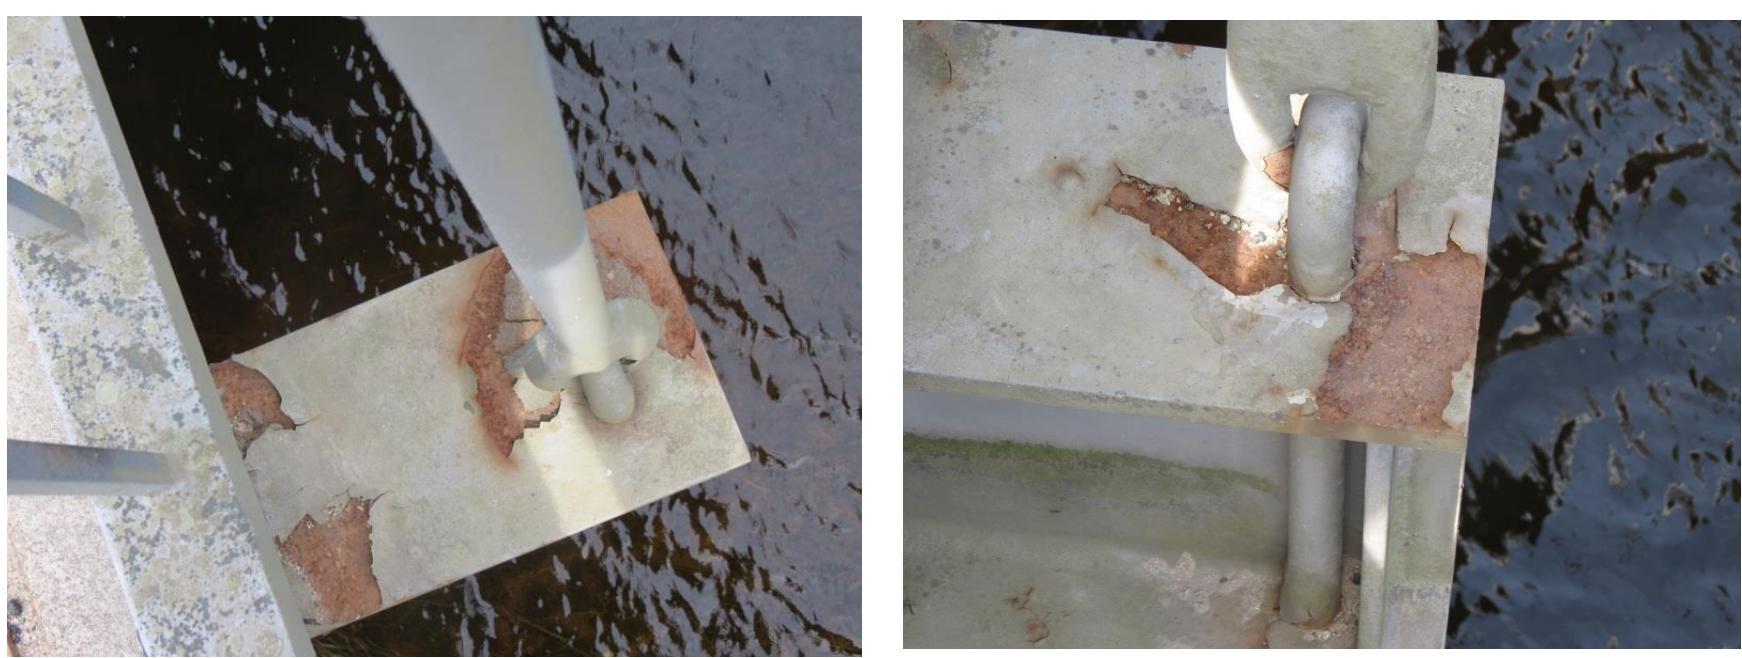
#### Transverse steel girders

- Generally good condition
- Starting corrosion in contact with edge girders and in sorroundings of hanger anchorages.

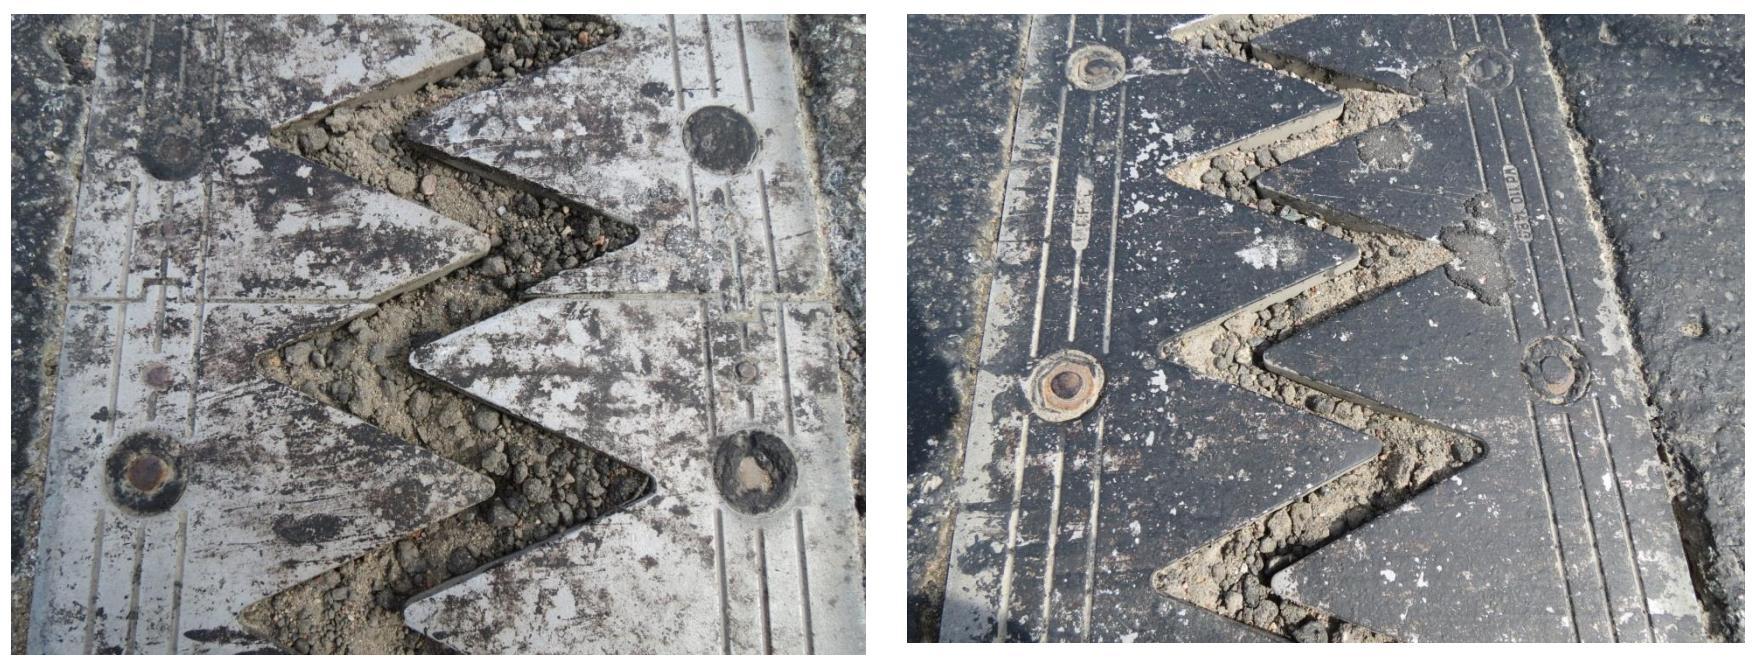
#### Joints

• Lots of debris in joints over both pylons

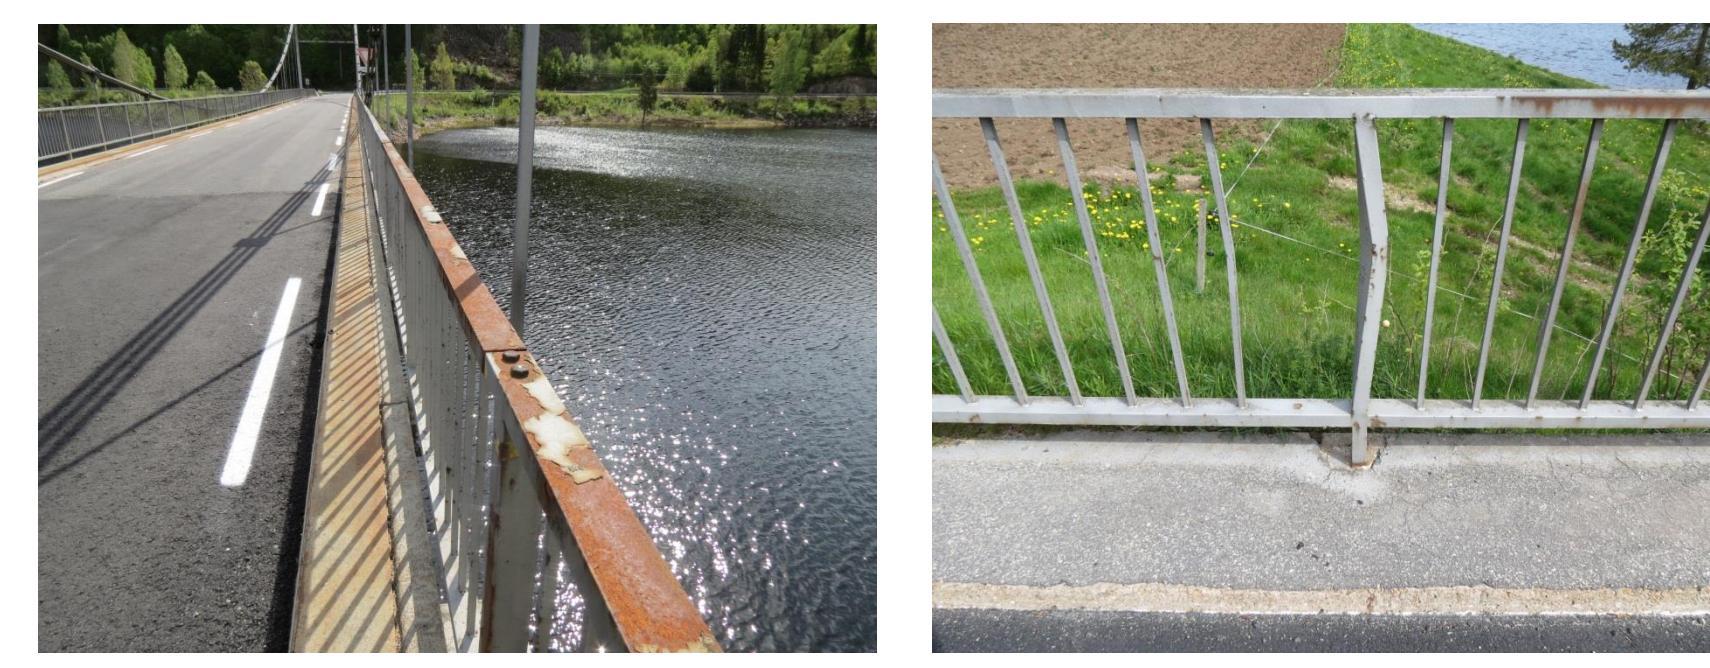
# Railling

- Extensive corrosion due to a lack of maintenance
- Puntual damages due to impacts

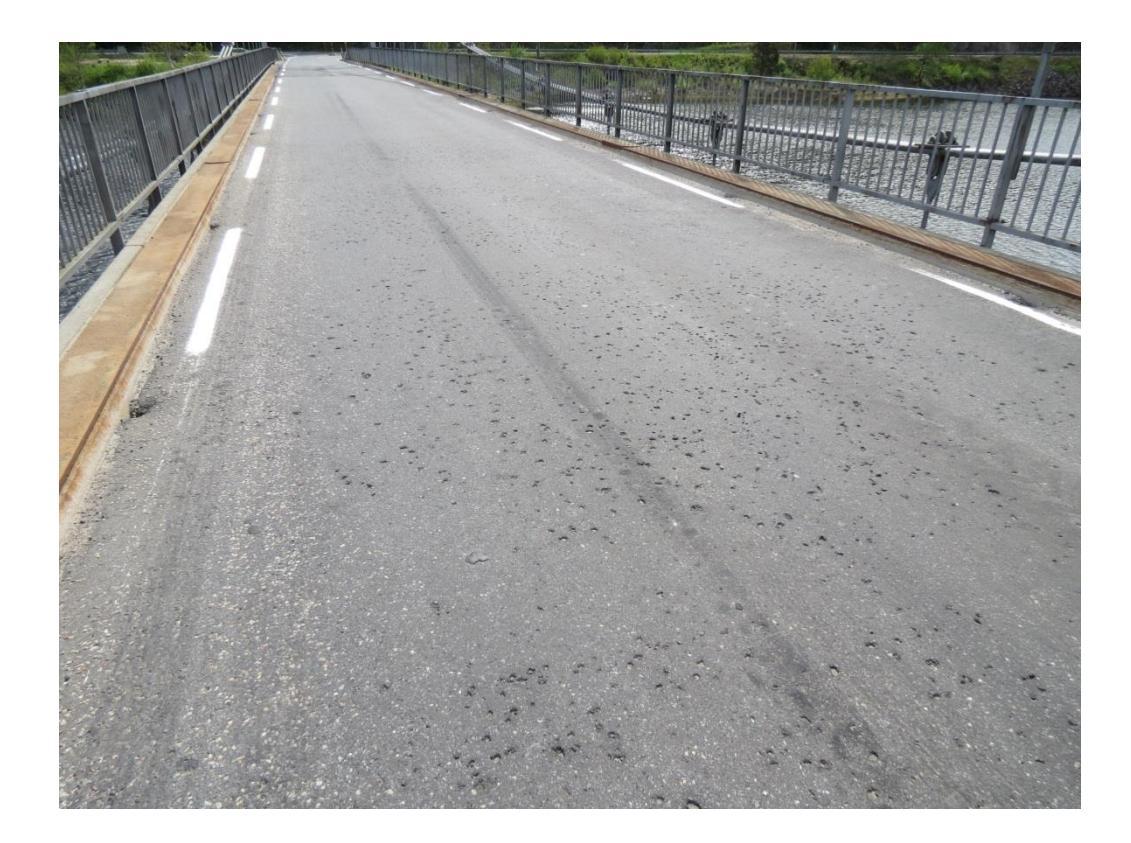
#### Pavement

• Good condition
